Sanitary Survey of Shallow Wells within Farms in Ainabkoi Sub-County, UASIN Gishu County Kenya

*Lydia L. Mbula Kitonga, Wilkister Nyaora Moturi, Samuel Mutuku Mwonga
& Isaiah Taabu (Deceased)*

London Journal of Research in Science: Natural and Formal

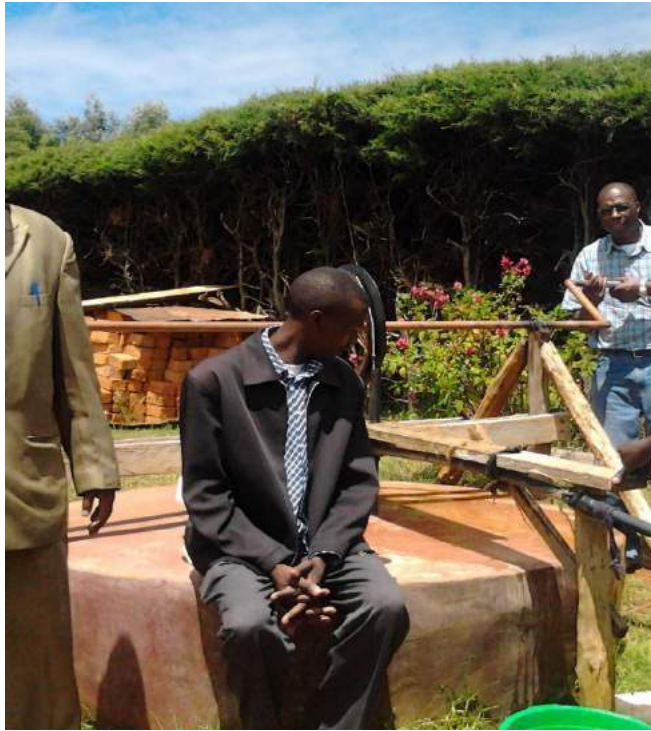
Figure 1: A protected well (parapet) with a hand-manipulated water extractor

The results of the sanitary risk conditions of the wells in the different farm sizes in Ainabkoi ward are presented in Table 1. The sanitary survey revealed that there were highly significant differences between the farm sizes in the sanitary contamination risk scores. The homesteads within the large and medium farm sizes were well organized and landscaped whereby farm areas were subdivided into functional areas. These functional areas included grazing paddocks, the main house and homestead area, kitchen garden area, recreation/relaxing areas and utility areas. The wells within the large farm sizes were privately owned, 30-40ft in depth and were either protected from runoff by a raised construction (parapet) or semi-protected with a concrete wall that was close to the ground surface and covered with iron sheets (Figs. 1 to 3).

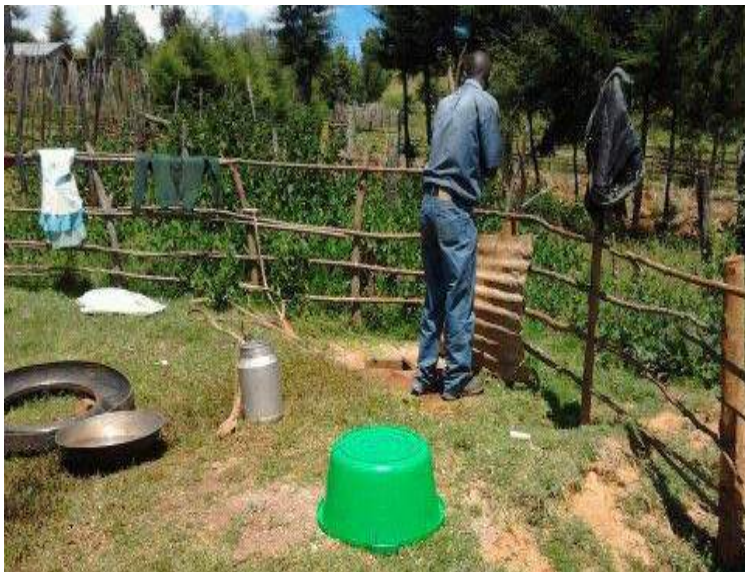
Figure 2: Semi-protected well showing the laundry activities and vegetable garden within the well vicinity a Large Farm Size

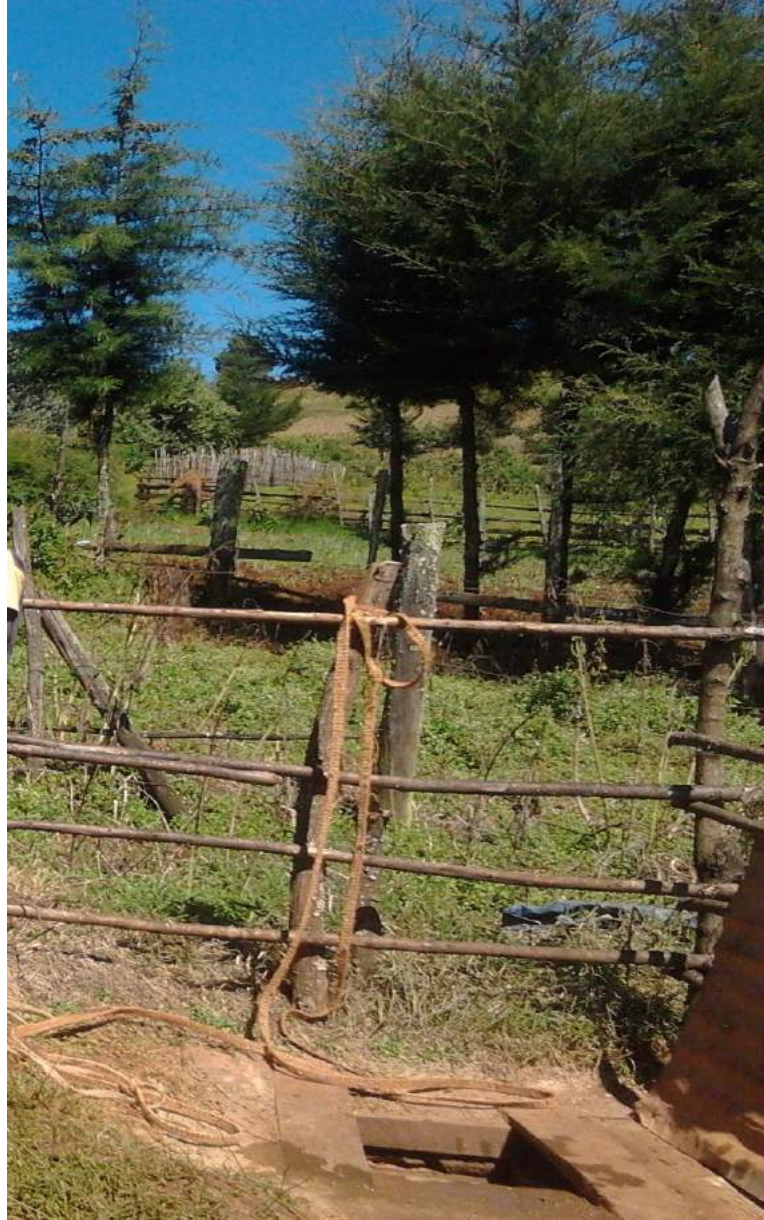
Figure 3: Close up of the semi-protected well in Fig. 2

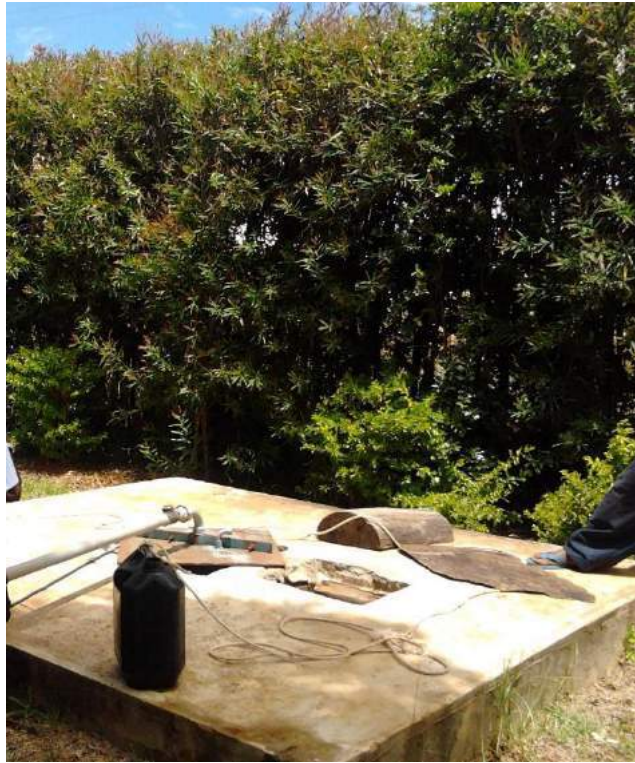
Figure 4: Protected well within a medium farm size showing modes of water extraction using a bucket and rope

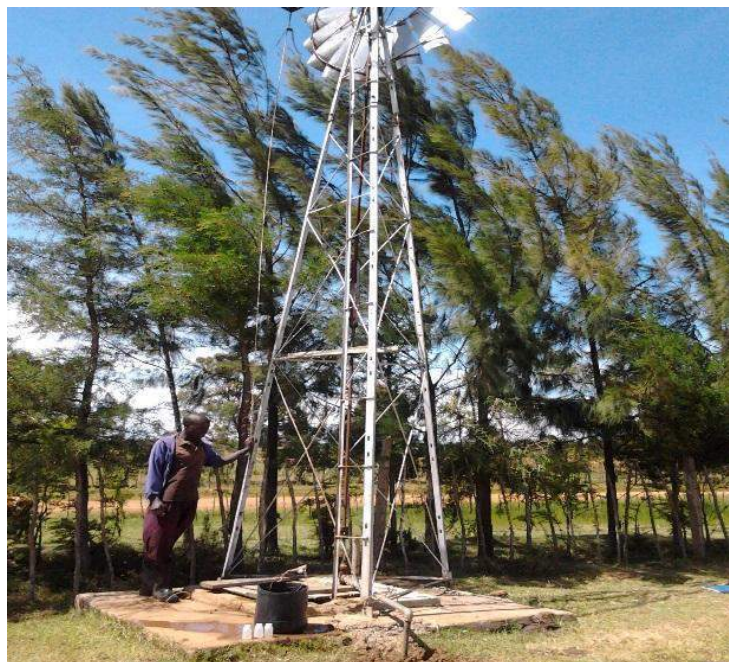
Figure 5: Protected wells within the medium farm sizes showing windmill mode of water extraction

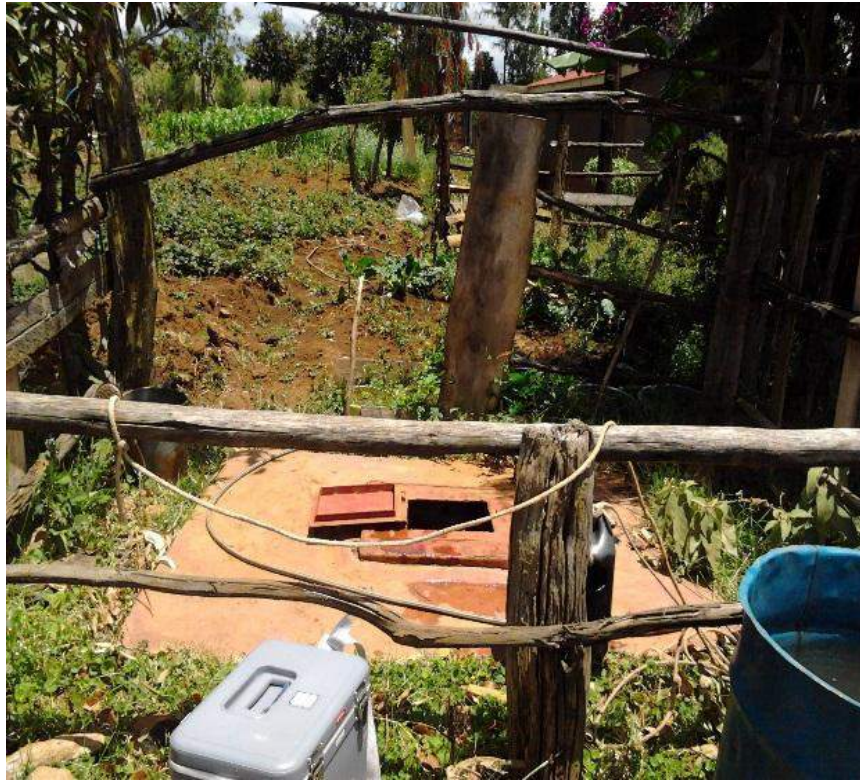
Figure 6: Semi-protected wells within the medium farm system surrounded by a vegetable garden

It was apparent that the water table in the region of the small mixed farm sizes of Olare ward was mostly high and therefore the wells were shallow and remained full throughout the wet and dry season (Fig. 6). These wells were located at the

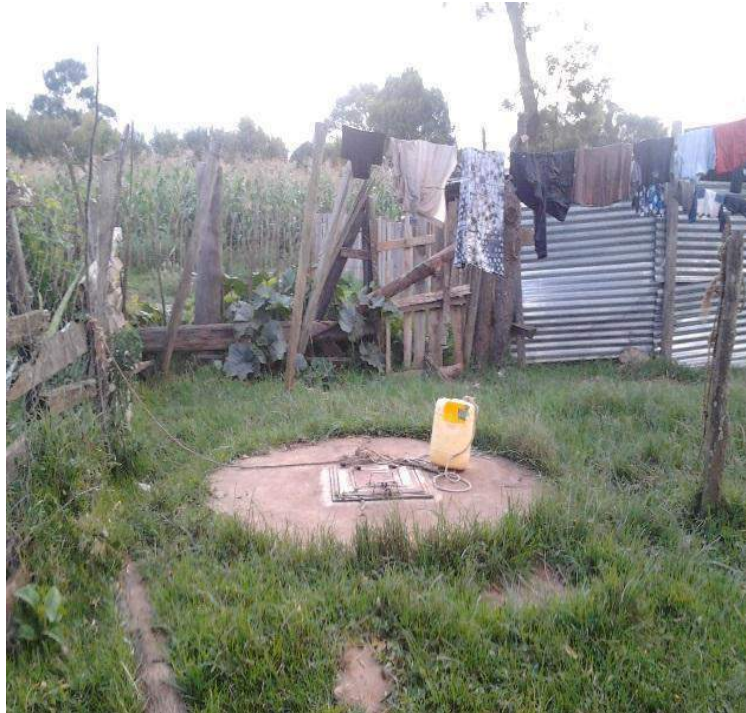
Figure 7: Semi-protected wells within the medium farm system surrounded by maize production in the vicinity of the well

bottom of the terrains or slopes which facilitated drainage and runoff down slope into the wells. Observation of the maize crop around the area around the well showed significant N fertilizer deficiency as shown in Fig. 7.

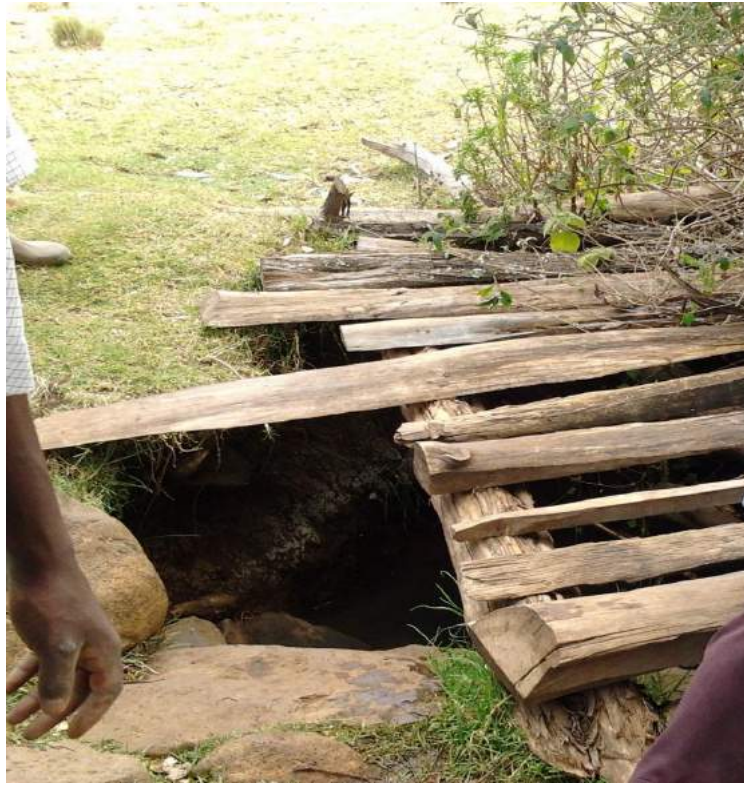
Figure 8: A shallow unprotected communal wells used for both home water consumption and also for watering cattle in the small mixed farm size

These wells in the small farm sizes have a very high sanitary risk because they are found downslope and are not protected by raised construction. Livestock are often tethered and watered within the well vicinity; hence any animal wastes are washed into the wells from runoff down slope. Water quality in wells is highly influenced by pollutants moving from upslope in the vicinity of the well. The deeper wells of the large farm sizes tended to have relatively lower

There is therefore need for a local county initiative to construct protective raised walls at the communal wells and educate the community on aspects of water quality. It will be necessary to evaluate the microbial load and thereby determine

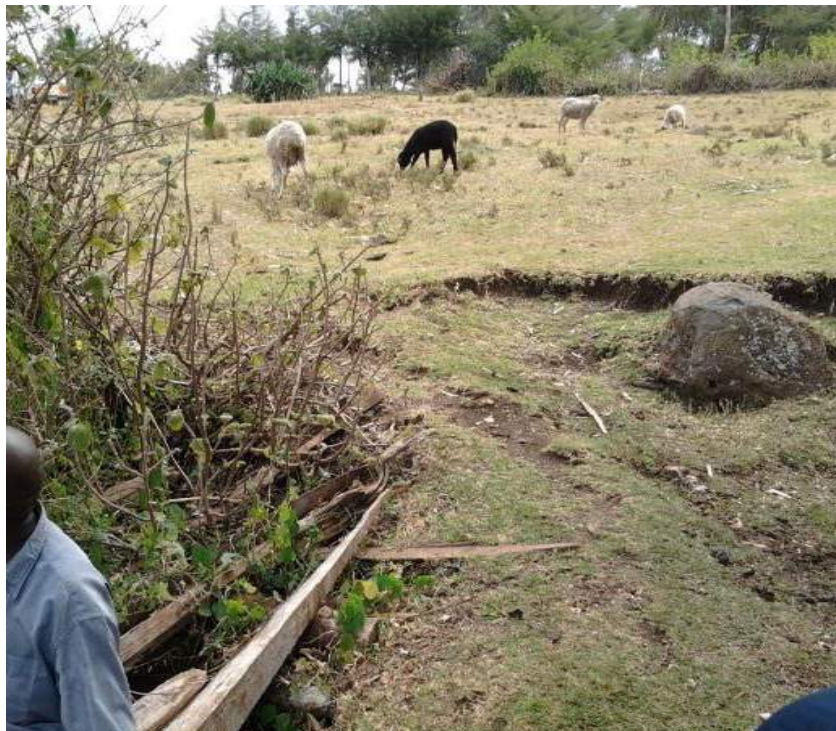
Figure 9: A communal shallow well within the small farm system showing livestock grazing (left) and cow dung (right) within the vicinity of the well

Most of the farms and homesteads within the small farm size, were not well planned. The houses were mostly semi-permanent and ranged from one house to about six houses within the homesteads. Wells within the small farm sizes were communally owned, shallow and unprotected making them vulnerable to pollution from runoff (Fig. 8-12). Water extraction from the wells was done by use of hand buckets and cans because the water wells were very shallow and the water level was always high. Within the small farm sizes, the general terrain sloped towards the wells and livestock were tethered to graze and were also watered in the well vicinity. This consequently littered the area around the well with animal excreta (Fig. 9).

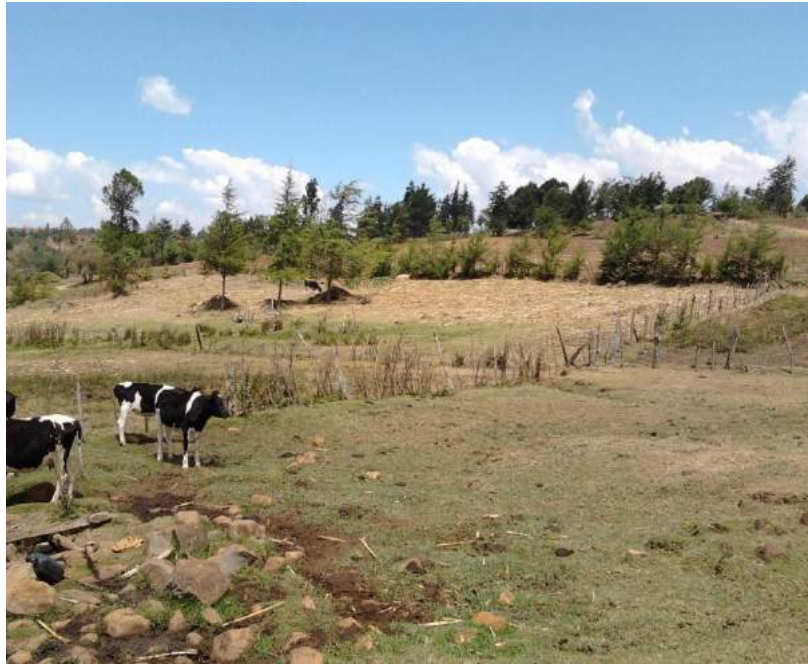
Figure 10: A communal shallow well within the small farm system showing livestock waiting for water and cow dung within the vicinity of the well

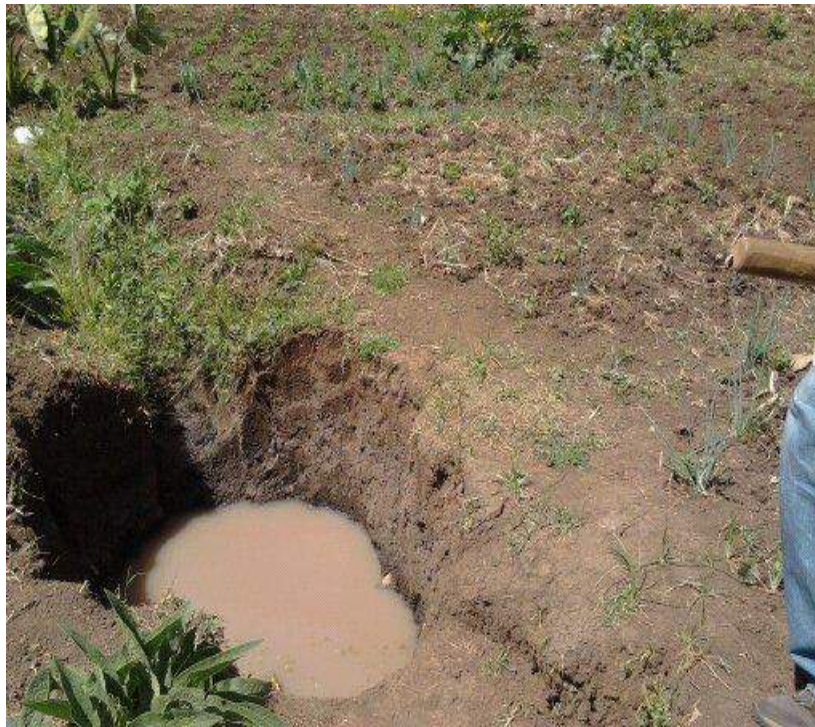
Figure 11: In a small mixed farm in Olare ward showing the visibly high water table (right)

The wells within the small farm sizes were shallow due to the high-water table within the area of Olare unlike the low water table found in the large and medium farm system areas of Ainabkoi and Kaptagat. Llopis-Gonzalez *et al.*, (2014), also reported that the depths of wells at high risk of contamination ranged from 0 to 300m and therefore making deeper wells have an increased

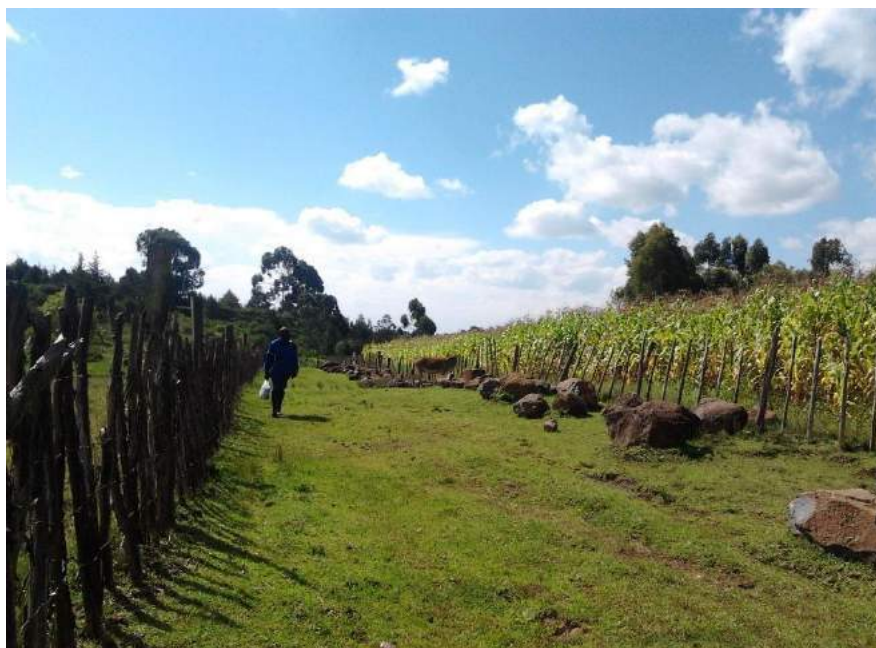
Figure 12: The road to a communal well in the small mixed farm system shows common N deficiency symptoms on the maize crop on the right
