### Challenges of Pedestrian Safety Management Along Bus Rapid Transit (BRT) Corridor in Dar Es Salaam City

Wilfred Gordian Kazaura Ardhi University

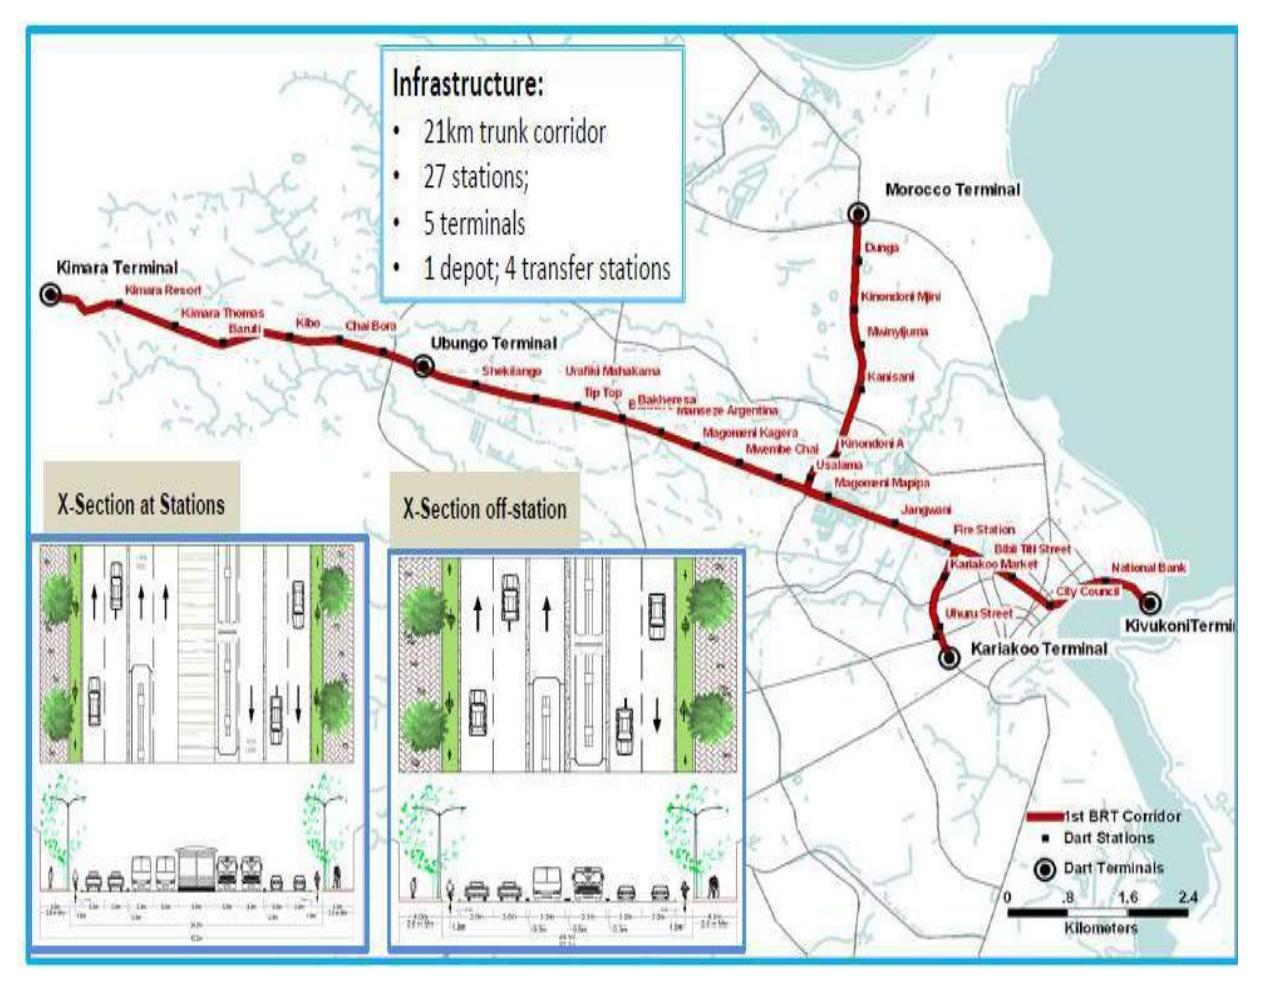
The study was conducted in Dar es Salaam along BRT corridor. As indicated in Map 1, the corridor comprises three main roads such as Morogoro road (Kivukoni to Kimara), Kawawa road (Magomeni to Morocco) and Msimbazi road (Fire to Kariakoo). Three categories of data were collected in the study area; the first category include driver and passenger assessment on the major causes of accident in BRT corridor. The samples size of 120 questionnaire were applied to collect data in four BRT routes and face to face interview were applied to interview 20 drivers and 100 passengers. Second category is data collected to assess the user perception and understanding the importance and use of road safety facilities in BRT corridor. It was collected by interviews performed in four BRT bus stops such as

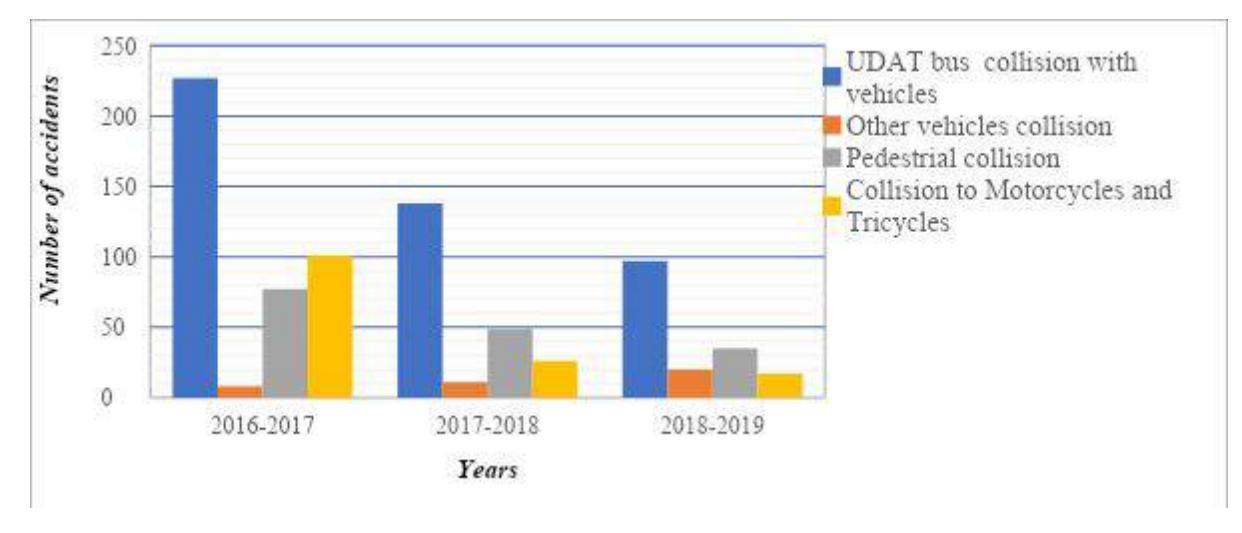
*Figure 1:* Accumulation of accidents in BRT corridor

BRT corridor is affected by different accidents taking place in different locations; however, 99 percent of accidents take place at the bus stops. As indicated in Figure 1, the accidents have been decreased from 413 number of accidents in years 2016/2017 up to 169 number of accidents in years 2018/2019. Collisions between BRT buses and other vehicles were very critical in 2016/17 and normally took place in junctions. Most of drivers were not keen in respecting regulations of separate lane (BRT lane) especially on major and minor junctions. Motorcycles and tricycles are also causing accidents due to the fact that they neglect regulations. Most of motorcycle and tricycle drivers are violating traffic rules, refuse to stop at zebra crossing and sometime drive in BRT lanes.

The accidents to pedestrians were taking place during crossing BRT lanes along the bus stops. The most affected locations include Manzese, Tiptop, Msimbazi bus stops and Gerezani terminal. These are highly populated areas concentrated with commercial activities and characterized by higher rate of BRT passengers per day. As indicated in Figure 2, people are facing difficulties in crossing the roadways and BRT lane to enter the bus stop or to go out of the bus stop. Number of injured include school going children, women going to shopping and visiting relatives, and few men especially youth and elders. Drunker and disabled accidents not often counted in BRT corridor.
